ULTRASONIC IMAGING OF INTERNAL STRUCTURES OF A FIBER STEERED COMPOSITE PANEL

David K. Hsu and John J. Peters
Center for Nondestructive Evaluation
Iowa State University, Ames, IA 50011

Richard D. Hale*
The Boeing Company
St. Louis, MO 63166

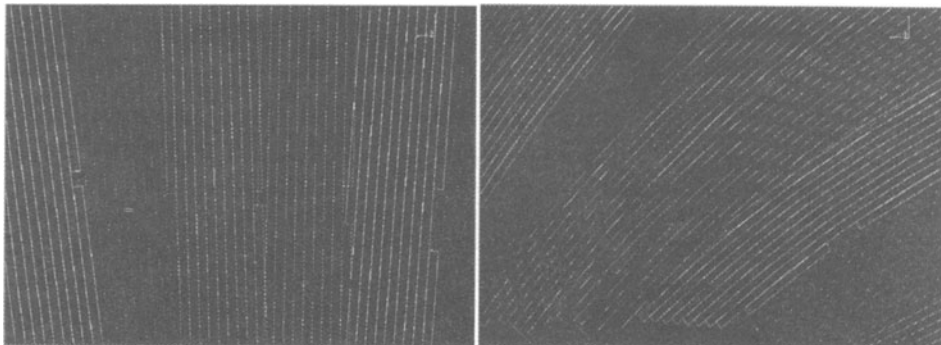
By design the 45°, 90°, and -45° plies have overlaps and gaps between the courses. The fiber placement machine was programmed to start and stop the outer edge towpregs so that the maximum amount of overlap or gap is 50% of a towpreg width. There are numerous starts and stops of towpregs in these plies. These starts and stops create "convergence gaps" or areas where the plies above and below move in to fill a gap. The starts and stops for the 45° and 90° plies can be seen in Figure 2.

Figure 2 Starts and stops in a 90° ply (left) and a 45° ply (right). Notice the gaps and overlaps created by the starts and stops.

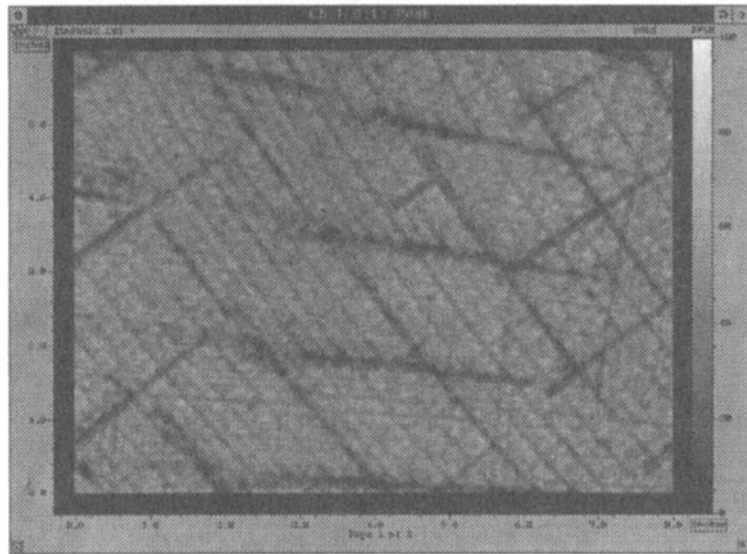
(a)

Ultrasonic C-scan images were obtained over portions of the fiber steered panel using a 15MHz, 0.5" diameter transducer with a 2" focal length. The focal point was placed on the back surface of the panel and a raster C-scan was made using the amplitude and time of flight of the back surface reflection. These results are shown in Figure 3. In these images, all fiber directions of the fiber steering panel were imaged. The 0-degree tows are nearly vertical in the figure and the 90-degree tows are nearly horizontal. The curvature of the ± 45 -degree plies was visible and the divergence of the 90-degree plies was also revealed. The dark streaks in the amplitude C-scan (Figure 3(a)) correspond to lower echo amplitude. They are probably caused by gaps and laps between courses of

towpregs. Notice that the 0° tows have the least number of dark streaks, which is to be expected. Since the C-scan images were based on the back surface reflection, they represent an integrated effect over the entire thickness. Future comparisons between the C-scan images and micrographs of sectioned samples should prove instructive.

Figure 3(a) Amplitude C-scan of 8'' x 6'' portion of fiber steered panel.

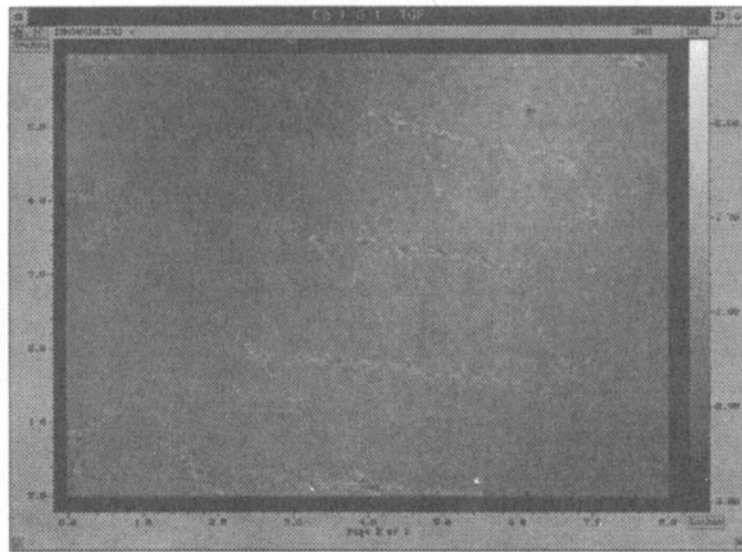
(b)

Figure 3(b) Time of Flight C-scan of 8'' x 6'' portion of fiber steered panel.

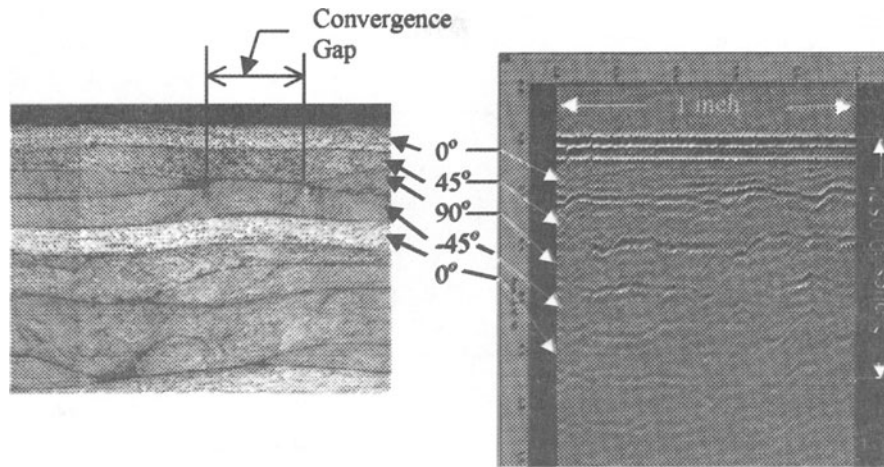
Figure 4 Micrograph (left) and B-scan image (right) showing the presence of a "convergence gap."

The internal ply structures of the fiber placed graphite epoxy laminate containing fiber steering were imaged ultrasonically with a high frequency (50MHz center frequency) focused probe with resolution better than a single ply thickness. A "convergence gap" in the 90-degree ply was detected and imaged (Figure 4). The ultrasonic images were obtained by conducting a B-scan with the focal point placed approximately at the midplane of the panel.

The optical micrograph of the fiber placed panel, obtained destructively, was not taken at the location of the ultrasonic B-scan. However, a comparison of the micrograph and the UT image shows that they both contain a clearly defined convergence gap in the 90° ply (third ply from the top surface). The horizontal and vertical axes of the UT image in Figure 4 are both length but in very different scales. It can also be clearly observed that the ply interfaces below the convergence gap were increasingly distorted. This distortion was caused by the presence of the convergence gap. Unfortunately, this means that anomalies in the laminate would cast a shadow below it in B-scan images and that the part of the sample located in the shadow of a shallower defect could not be imaged faithfully.

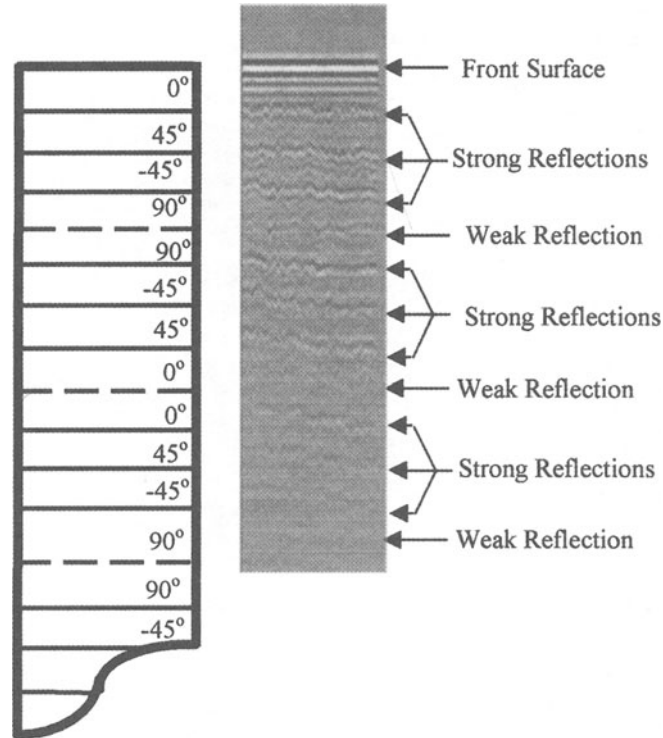
The ultrasonic B-scan image in Figure 5 shows that the quality of the panel (judged by the parallelness and flatness of the plies and the reflection strength of the internal surfaces) may be evaluated using B-scan imaging at high frequencies. A good quality panel would presumably have flat interfaces that are only weakly reflecting.

Figure 5 B-scan image of quasi-isotropic tape lay-up laminate.
